Saskatchewan
Agriculture, Food
and Rural
Revitalization

2003 Surface Water Quality Monitoring Report For Intensive Livestock Operations

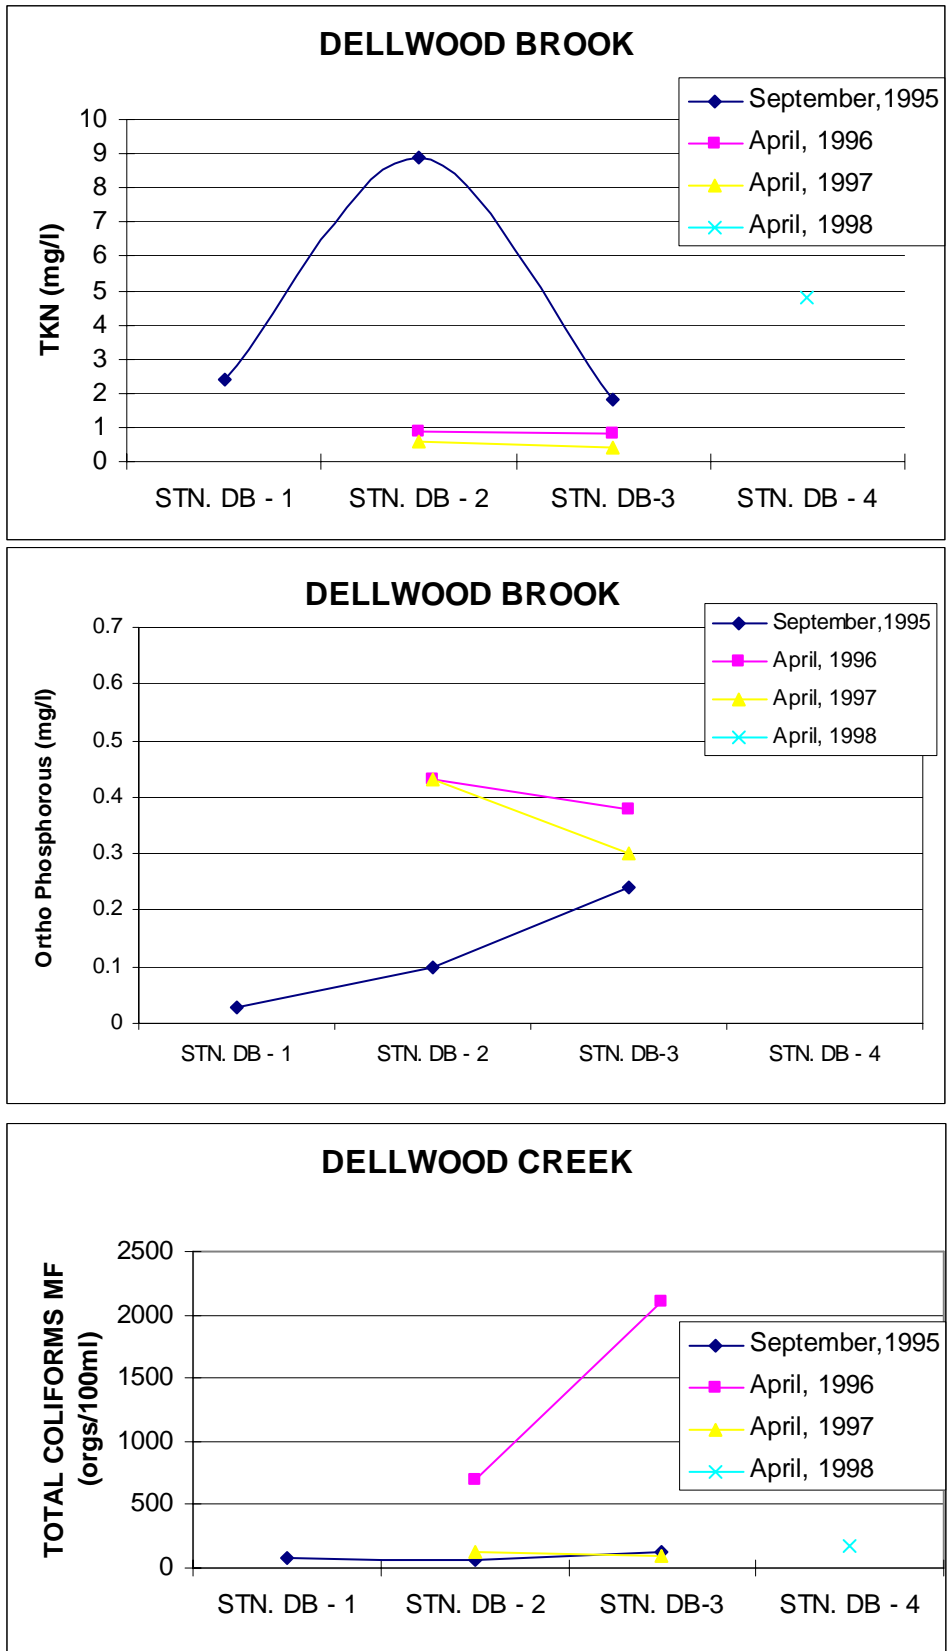
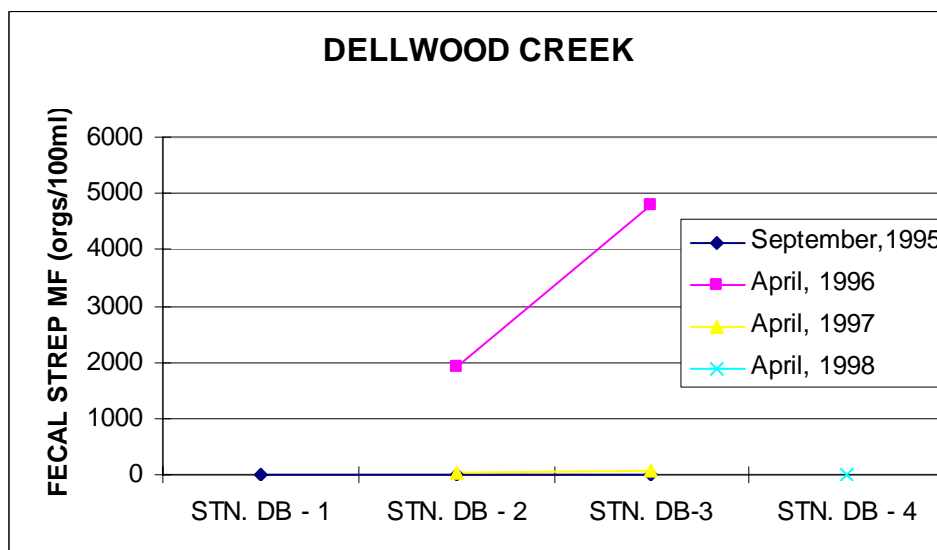
The following charts show the water quality of the Dellwood Brook watercourse for each year of sampling from upstream to downstream locations:

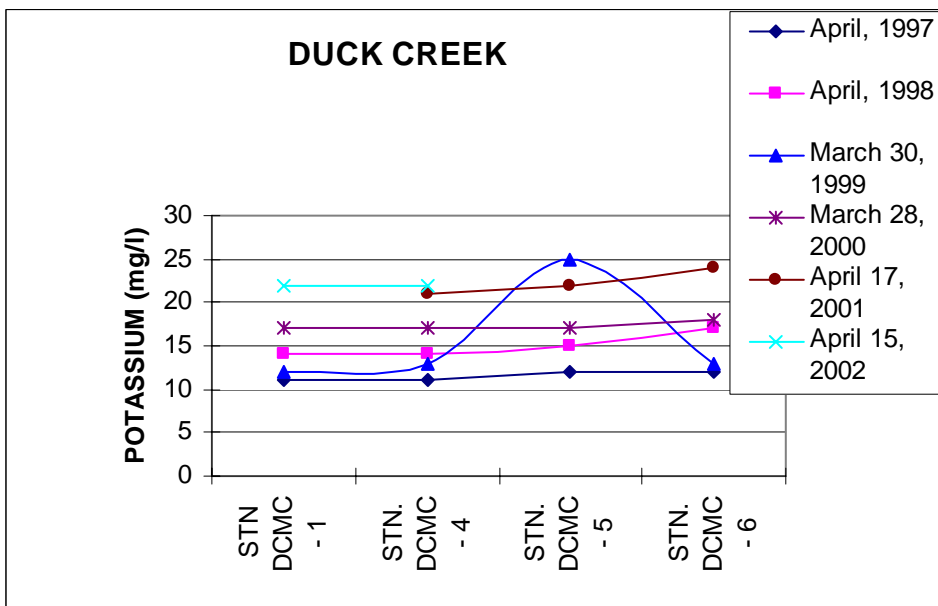
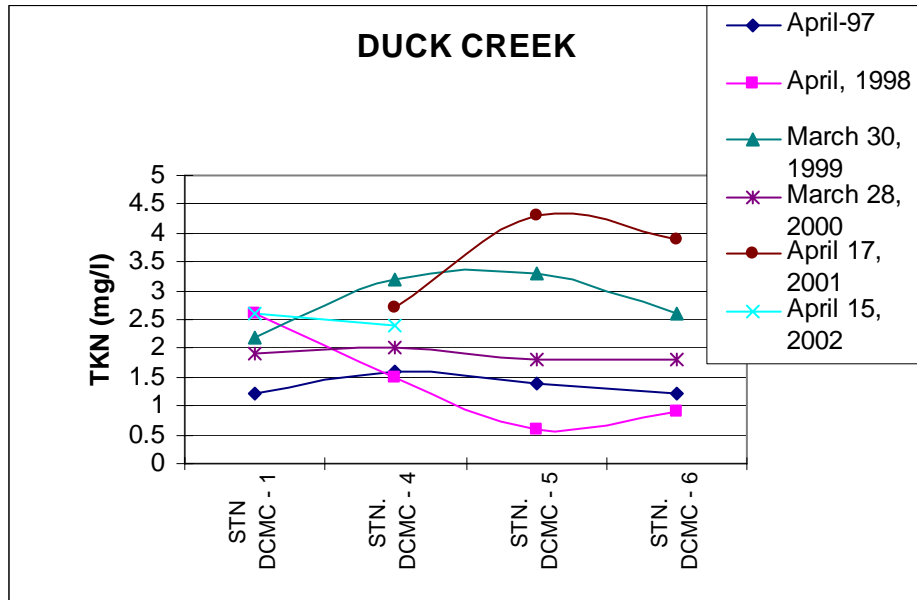
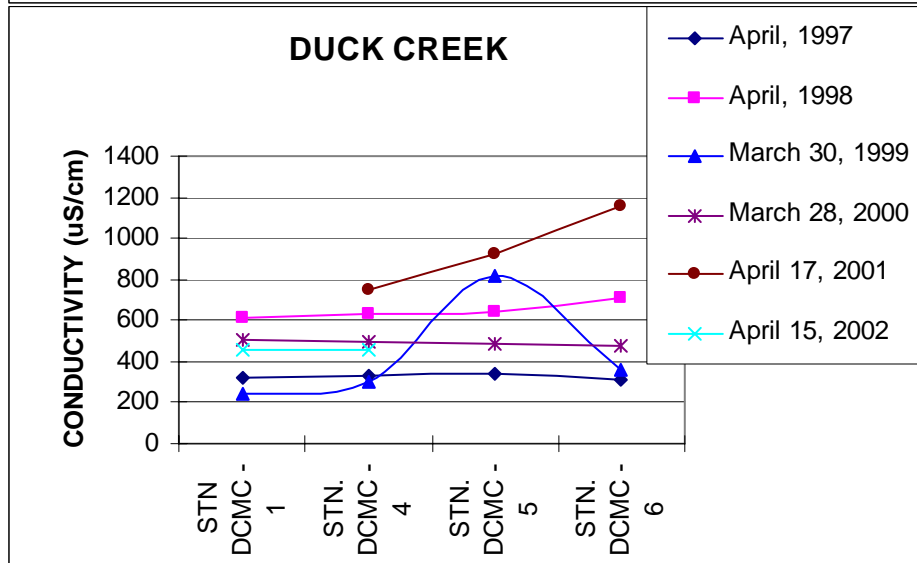
The following charts show the water quality of the Duck Creek watercourse for each year of sampling from upstream to downstream locations:

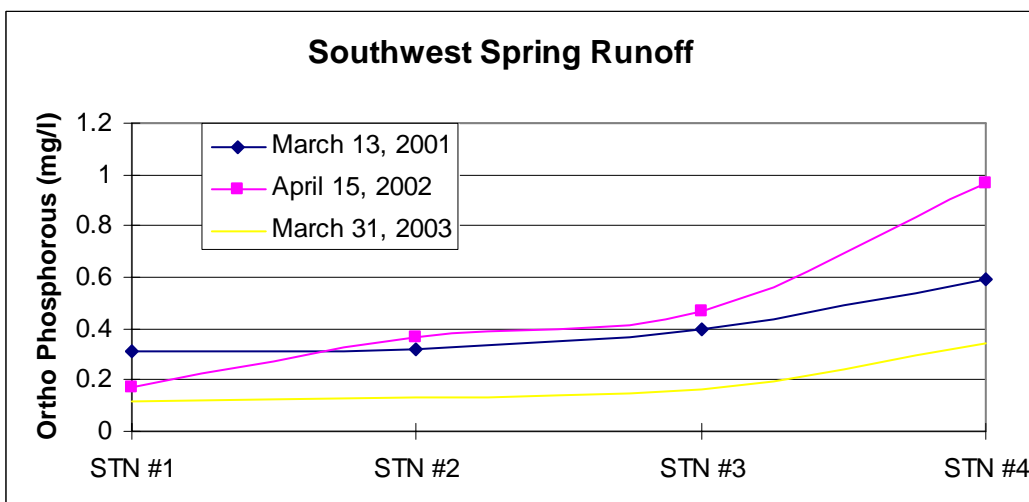
The following charts show the water quality of the sampling sites for each year of sampling from upstream to downstream locations:

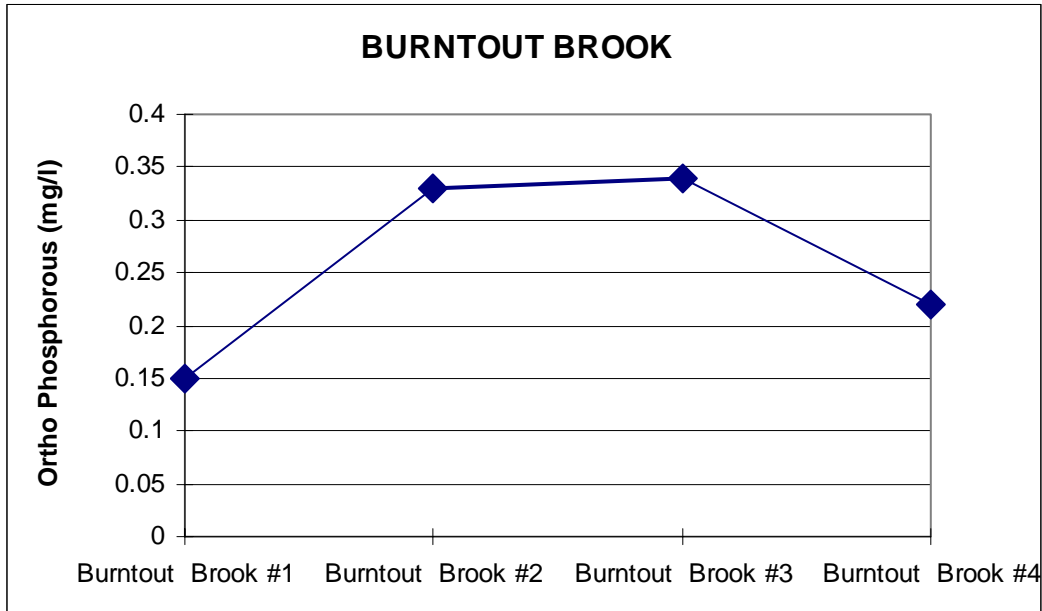
The following are the results of the baseline samples from the Spring runoff of 2003.
